# Area Assessment-Urban Center and Port

## 1.1. Urban Center 2 – LOCAL PROVINCE

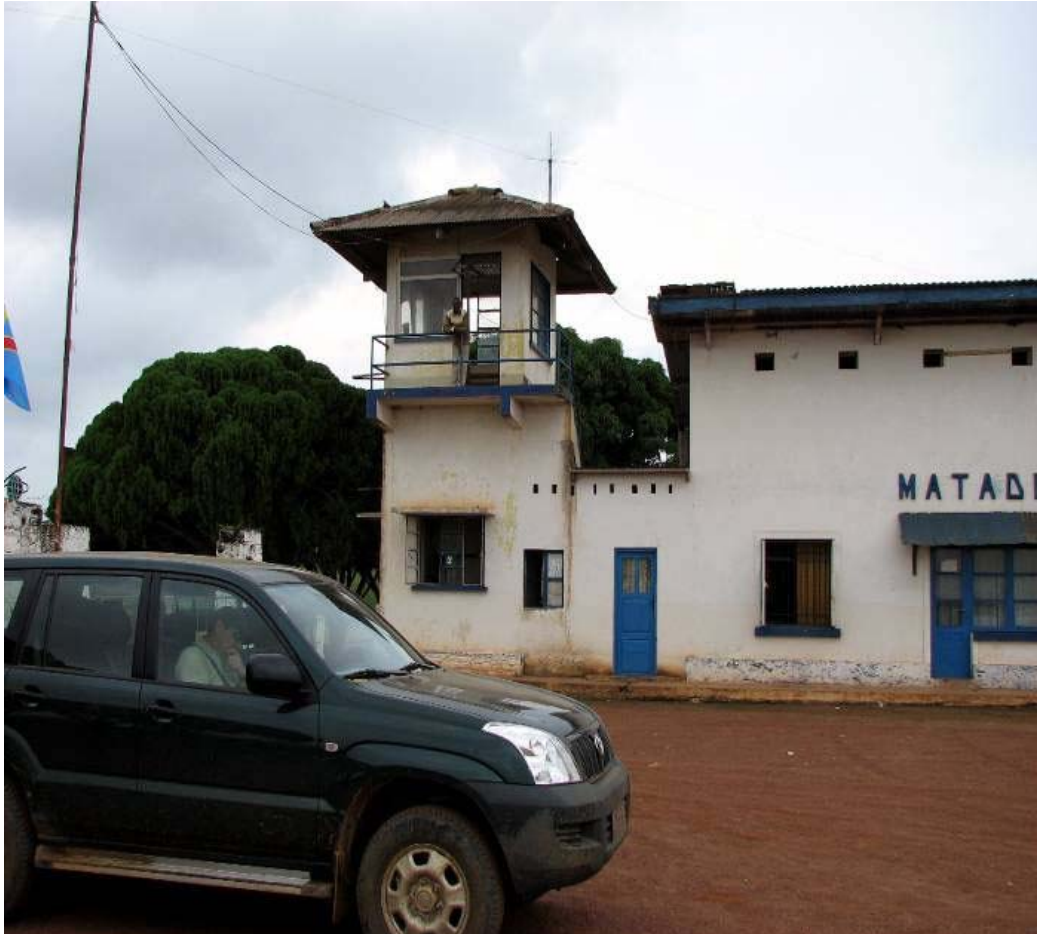
Figure 1 – Local Air Tower and Offices

The airfield is a colonial period structure and has been minimally maintained since the local independence. See Figure 1.

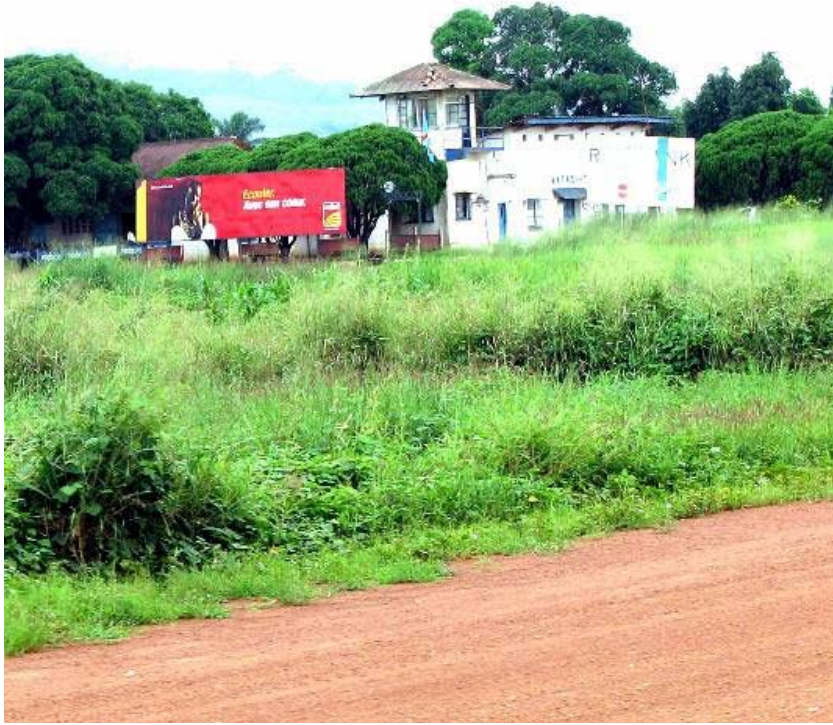
Figure 2

The terminal is essentially a large open room with no conveniences. Improvement or even replacement of the structure should be considered within your infrastructure development effort. See Figure 2.

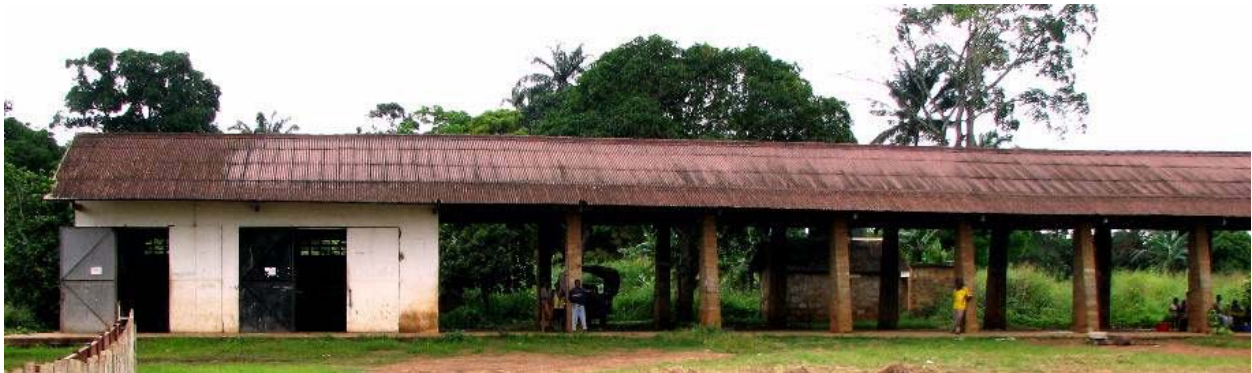
The airport facility depends upon diesel powered electric power generation. Diesel power is the only option since power lines from City Center to the airport do not exist. The generator is located in a covered shed that was offered to the assessment team as temporary warehouse space should client operations be conducted at the airport.

Figure 3 - Location of Generator and Storage Shed

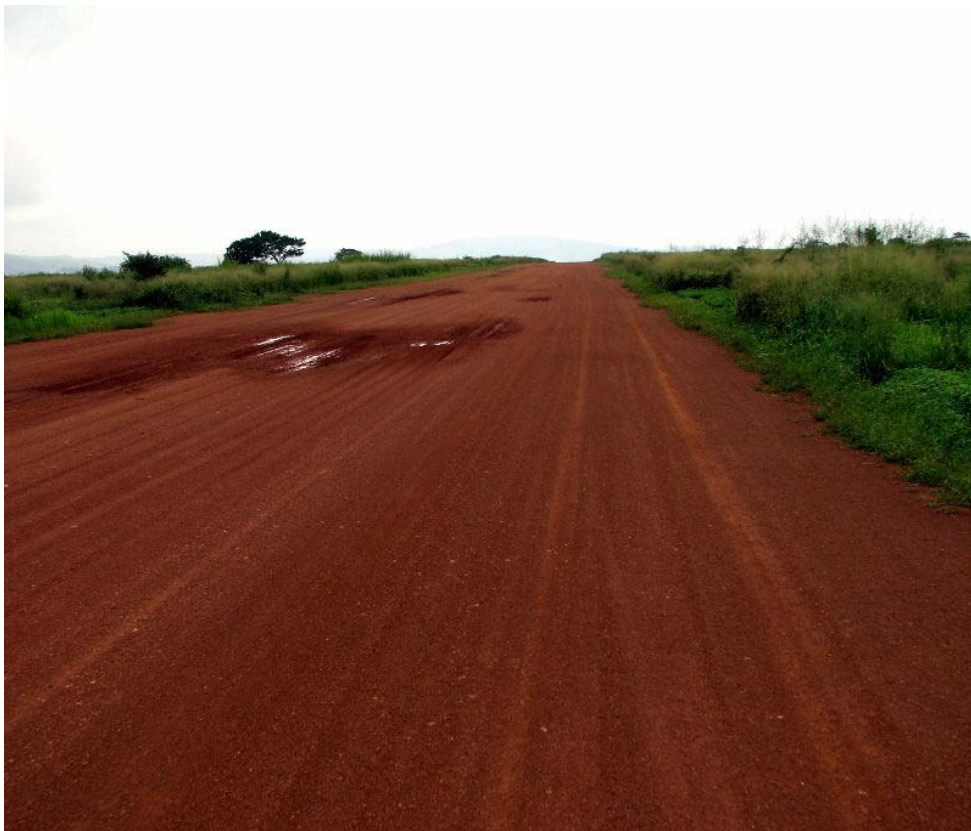
The runway is packed clay quartz aggregate and is maintained in relatively good condition. (See Figure 5)

Figure 5 - Local Runway-1600m

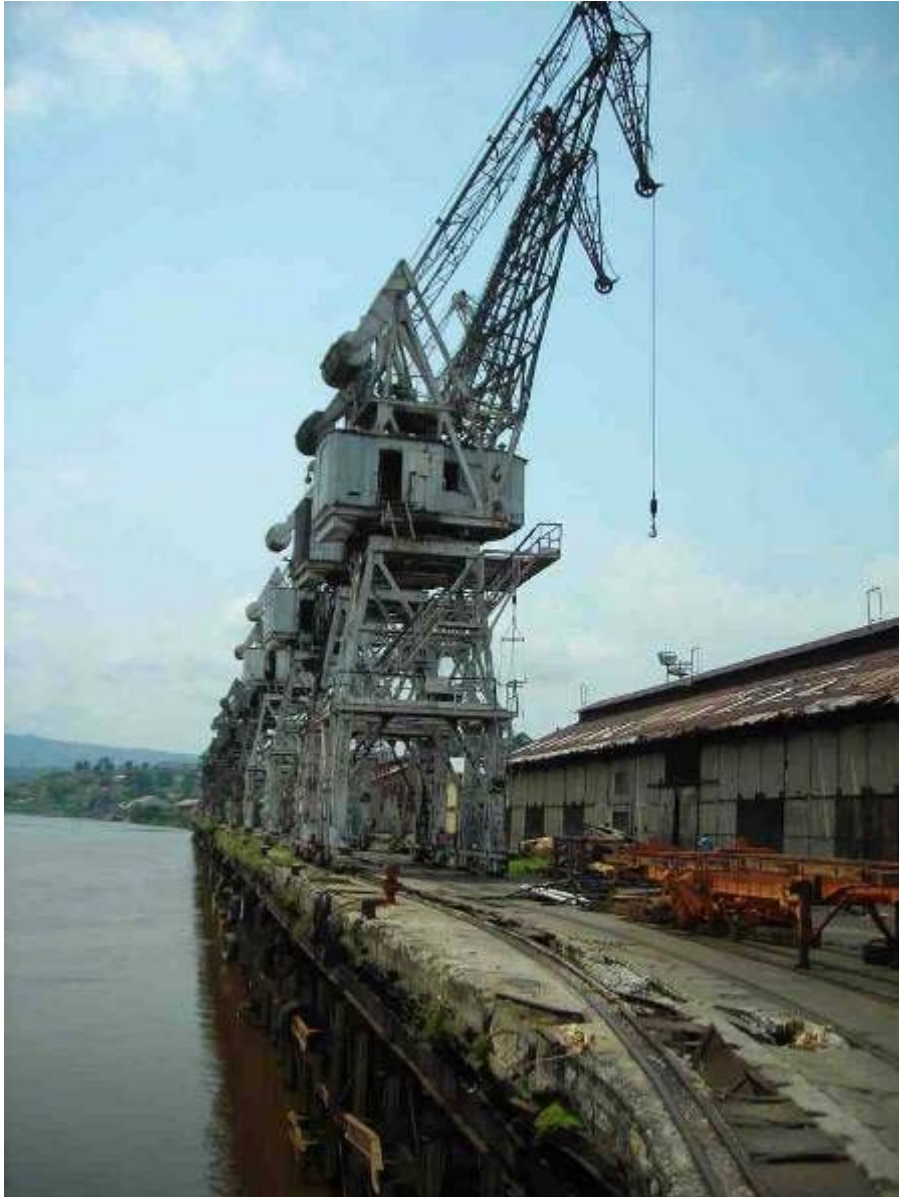
Antiquated heavy lift cranes were observed on the furthest northwest point of the pier. These cranes are neglected and are permanently out of commission. See Figure 13.

Figure 13 - Non-Operational Dock & Cranes

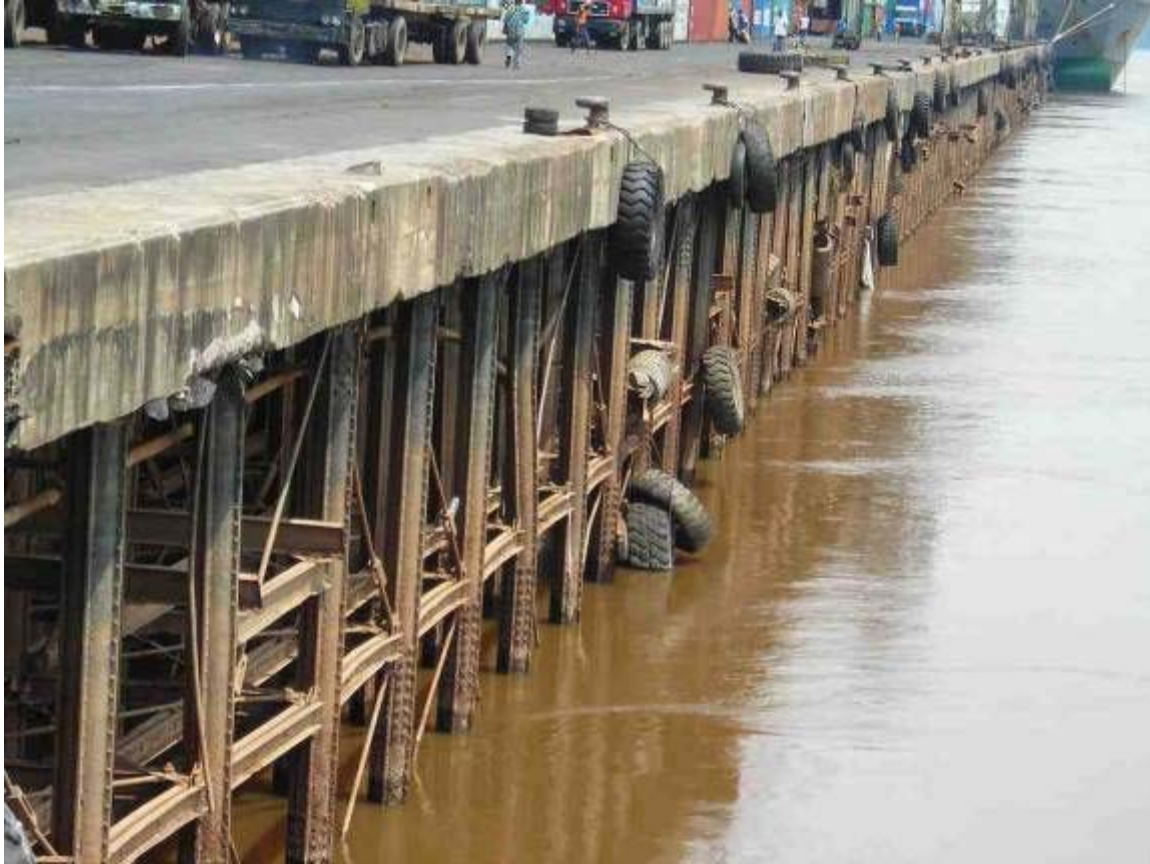
The pier itself is composed of underlying tar-impregnated poles and steel I beam construction that showed minimal tidal erosion, but was not fully evaluated for structural condition. Rebar-reinforced cement slabs were in good condition in high traffic areas and black tar was evenly distributed in others, again, appearing to be well-maintained. Rail systems along the pier were in uniformly decent condition, and in regular use.

Figure 14 - Operational Dock Pilings
