# Area Assessment-Urban Center and Port

## 1.1. Urban Center 2 – LOCAL PROVINCE

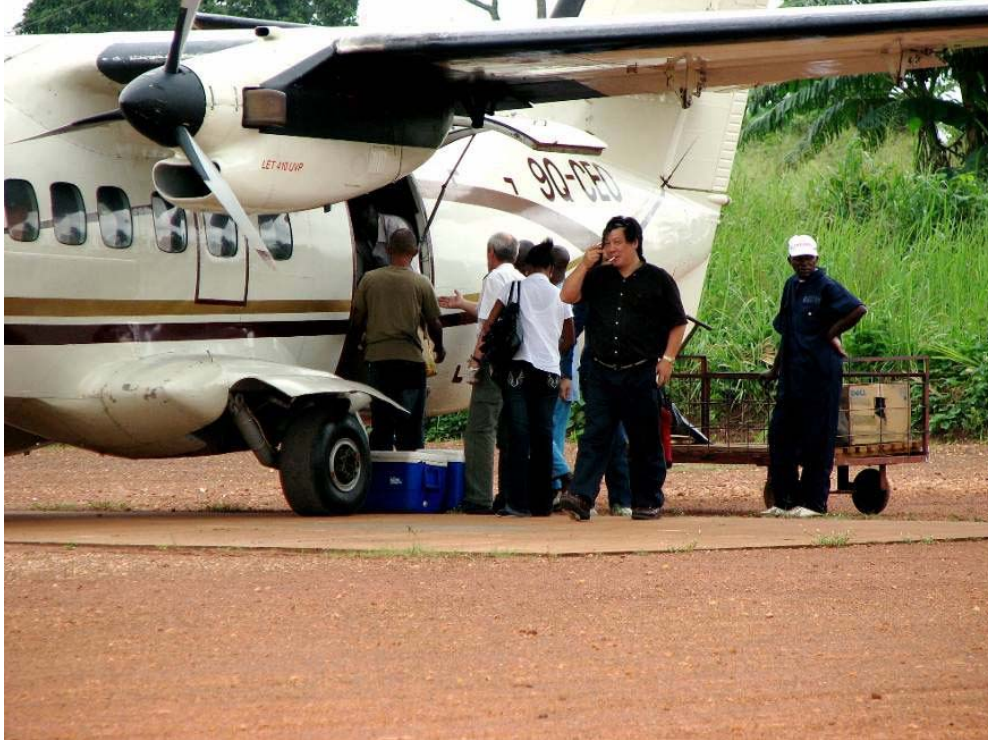
Small to medium size packages may be shipped on the above passenger flight as cargo. The weight is restricted to 15 kilos/ per package. Larger cargo may be flown on a chartered Antonov 32 or Fokker 27. See Figure .

Figure 6 - Arriving flight with passengers and cargo

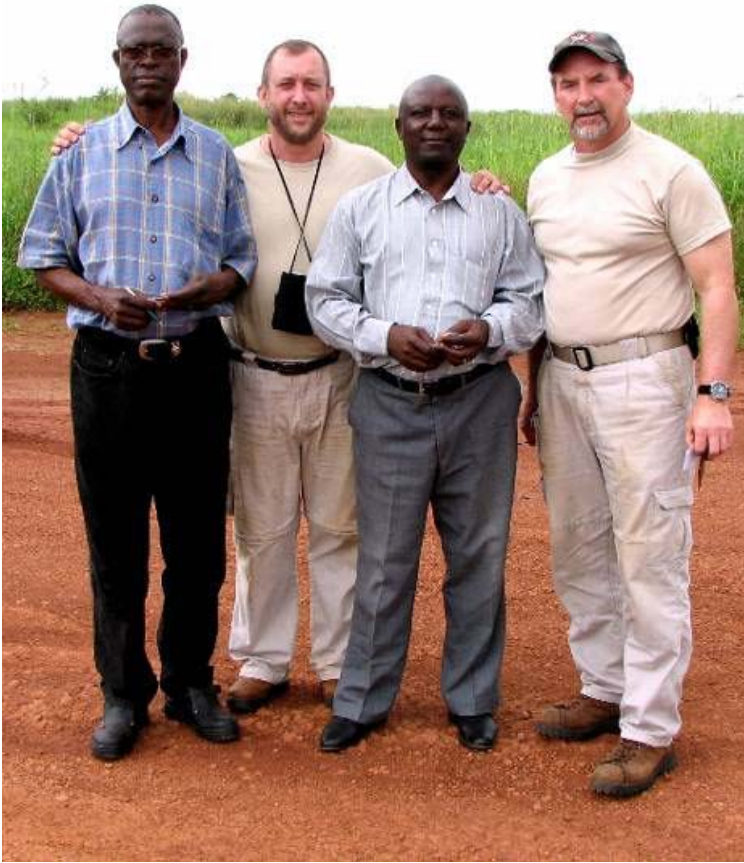
Figure 7 - Mr. X and Mr. Y with Assessment Team representatives

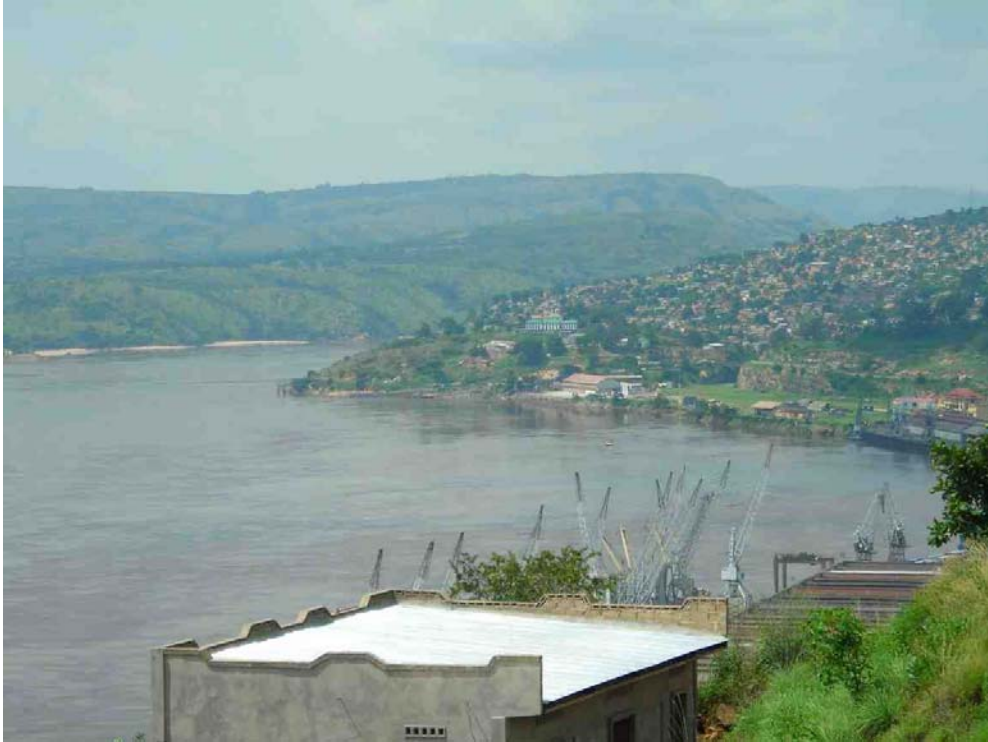
Figure 8 – Local Port from Overlook

The Local Port was assessed to be a well-managed and a secure facility suitable for light to medium cargo. It handles an average of one light cargo ship per day, and is run by a local contractor.

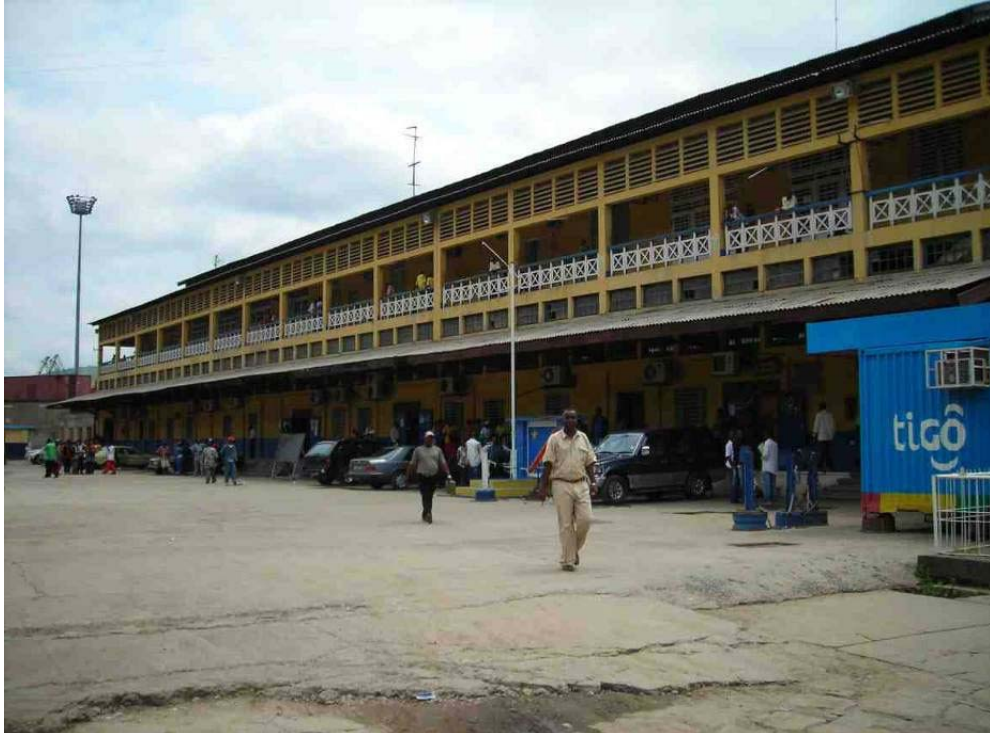
Figure 9 - Port Administration Building

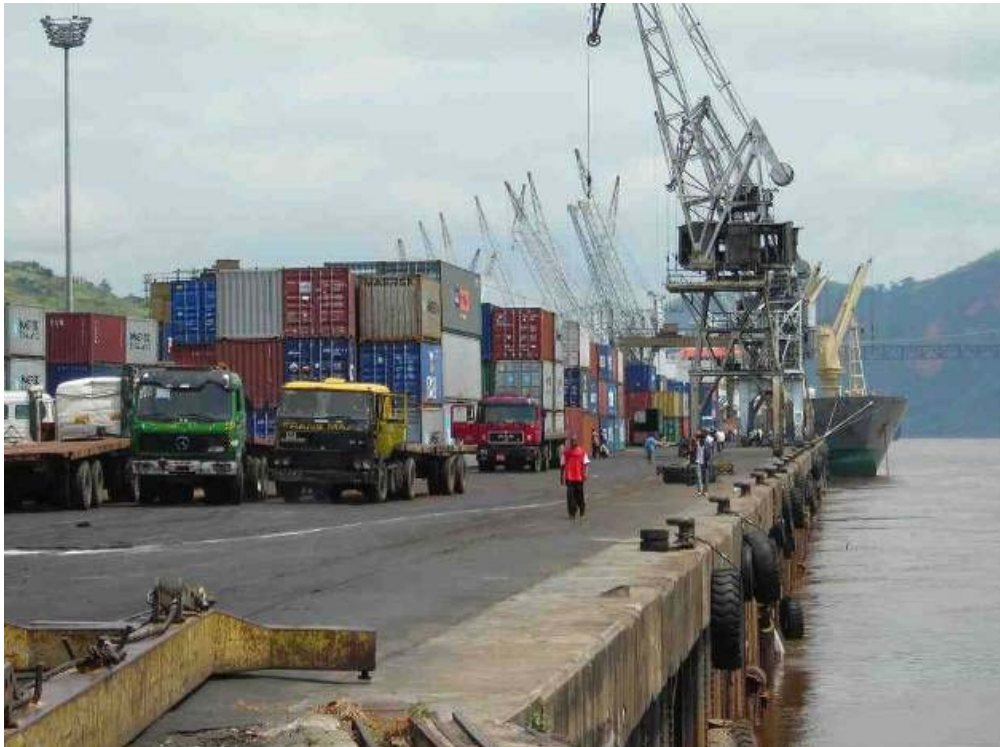
Figure 10-Operational Dock & Crane Area

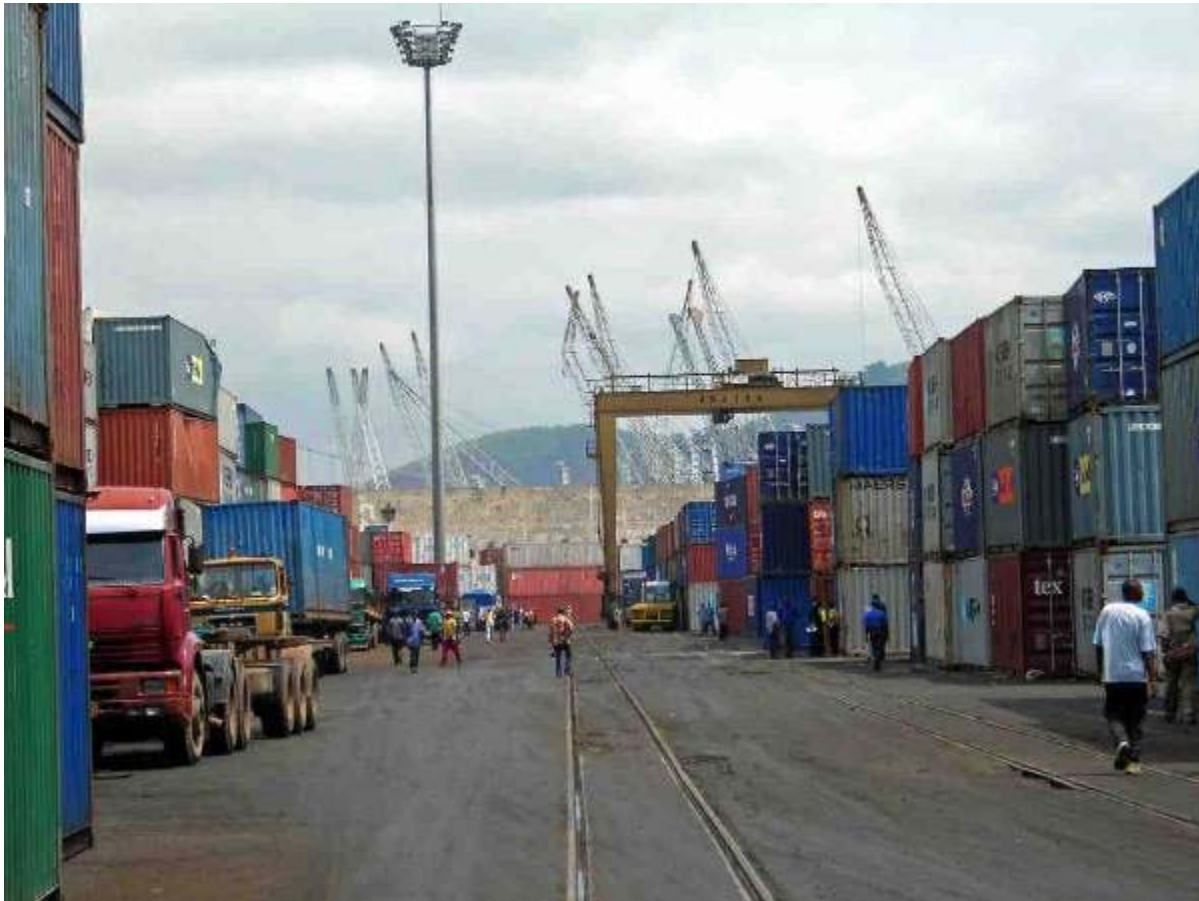
Figure 11 - Operational Dock With Rail Line

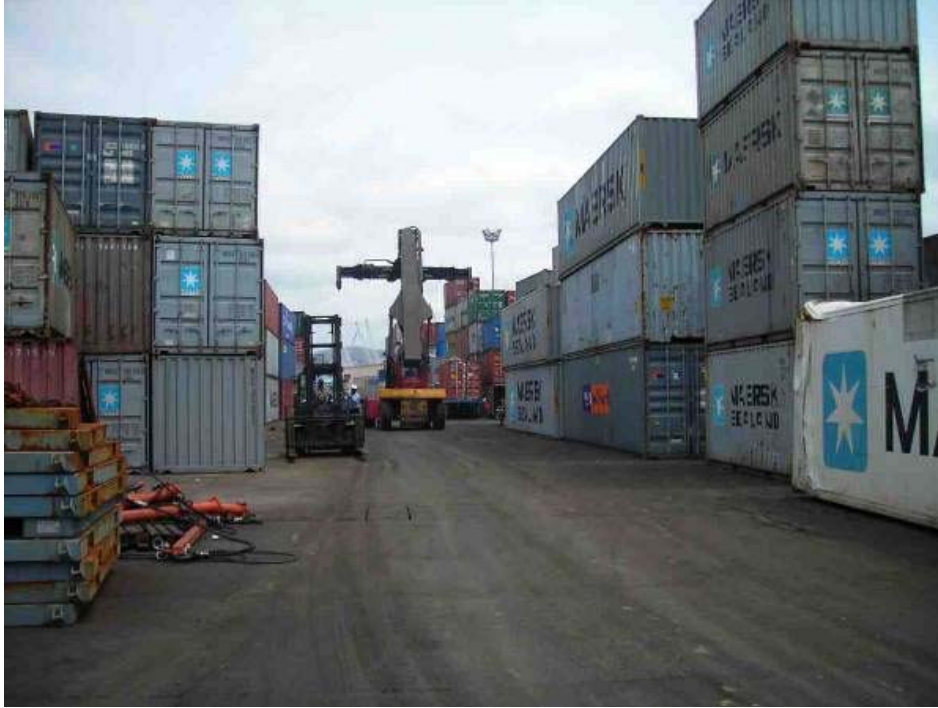
Figure 12 - Container Load/Offload Area

In the container area a light crane was observed offloading a light cargo ship (approx 3000 tons). Multiple mobile, light cranes were sighted, and were all reportedly operational, but the Assessment Team members only observed one in motion. The operator used the crane skillfully for the short time observed. Containers were stacked three deep and as high as four tall in some areas.

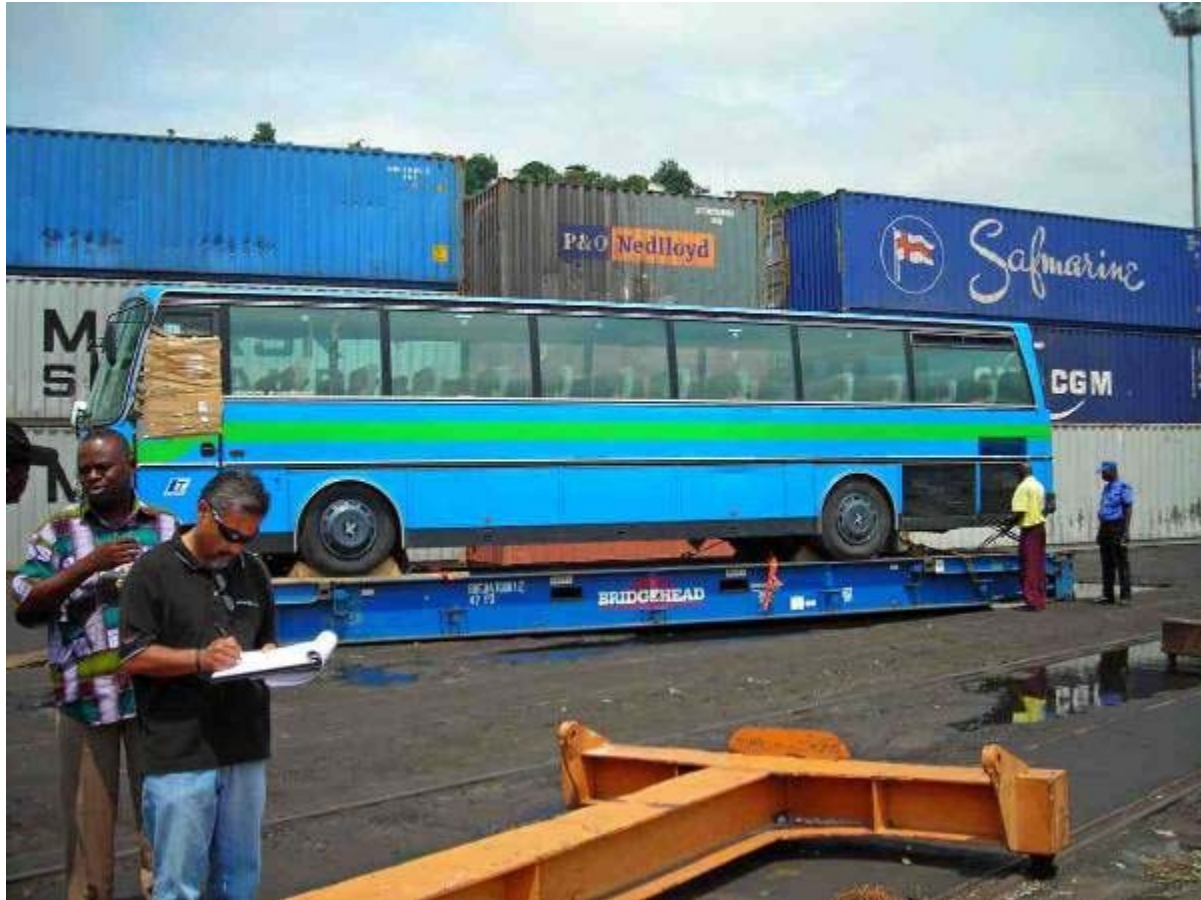
The inter-modal transfer area was lined with hundreds of trucks being loaded by large front-end loaders in an orderly and deliberate manner, and it appeared that drivers were given trip manifests and instructions prior to departure. The Team also observed buses, and other large vehicles being offloaded. The team did not observe any loading of rail cars, although there were flat bed rail cars available.

**Figure 15 – Offloading Bus**
